**Report No:** M19-0785  
**Date:** 11<sup>th</sup> March 2019  
**Client:** AustBore Pty Ltd  
**Contact:** Anthony Anastasi  
**Subject:** The initial Magnetic Particle examination of welds, bolt holes and transitions to suit one [1] EX5500 Carbody.  
**Test Location:** 12 – 16 Progress Drive, Paget QLD 4740.  
**Order No:** P31944  
**Client Job No:** J19955  
**Technician:** Jordan Geisler

The initial Magnetic Particle examination of welds, bolt holes and transitions to suit one [1] EX5500 Carbody.  
Job number: J19955

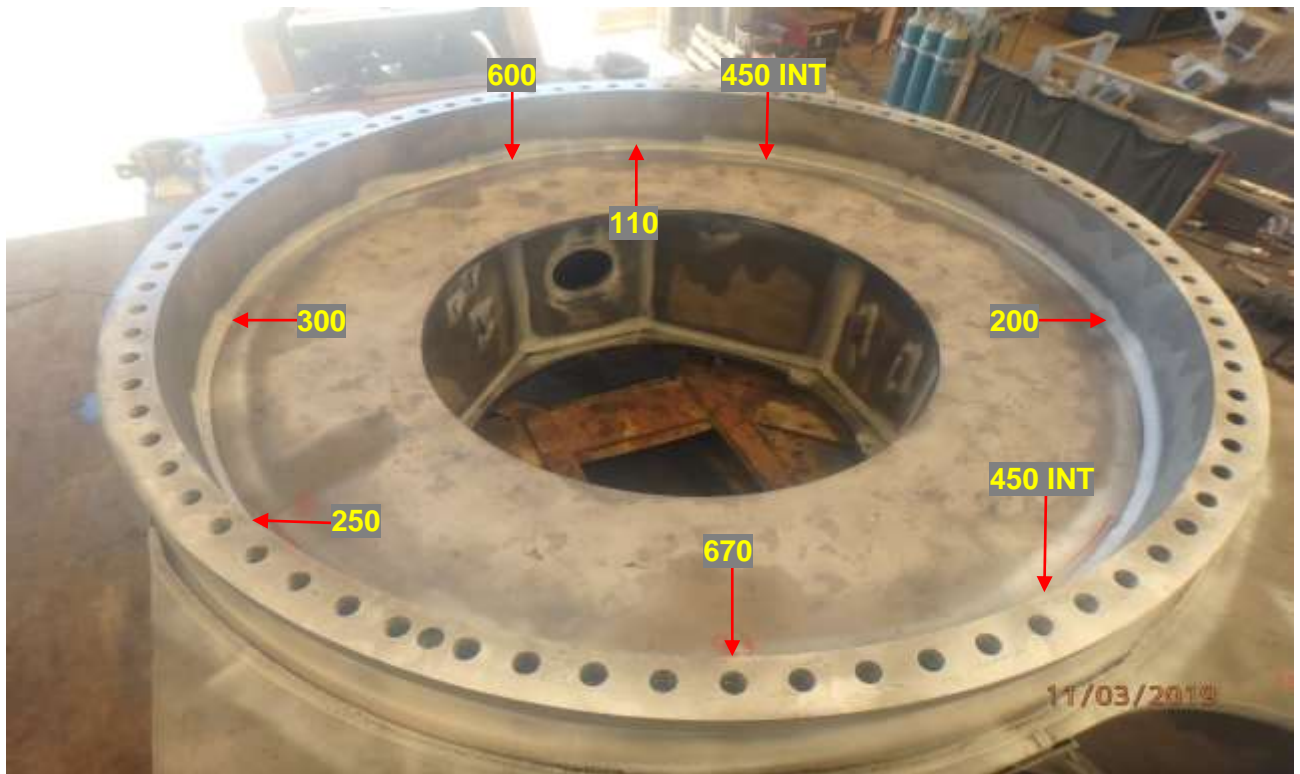
**Photograph 1.1.**

General view of areas examined and cracking detected about Carbody, Top Internal JNJ19955

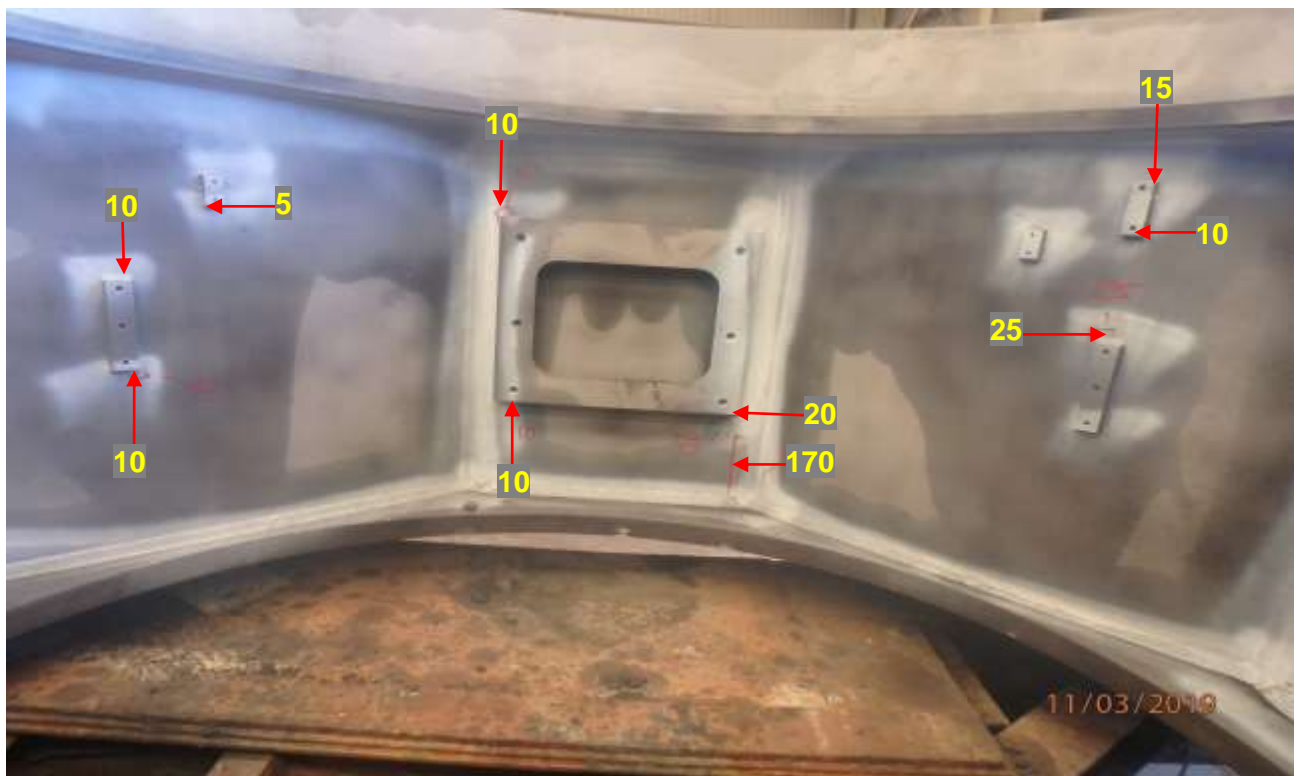
**Photograph 1.2.**

General view of areas examined and cracking detected about Carbody, Front Internal JNJ19955

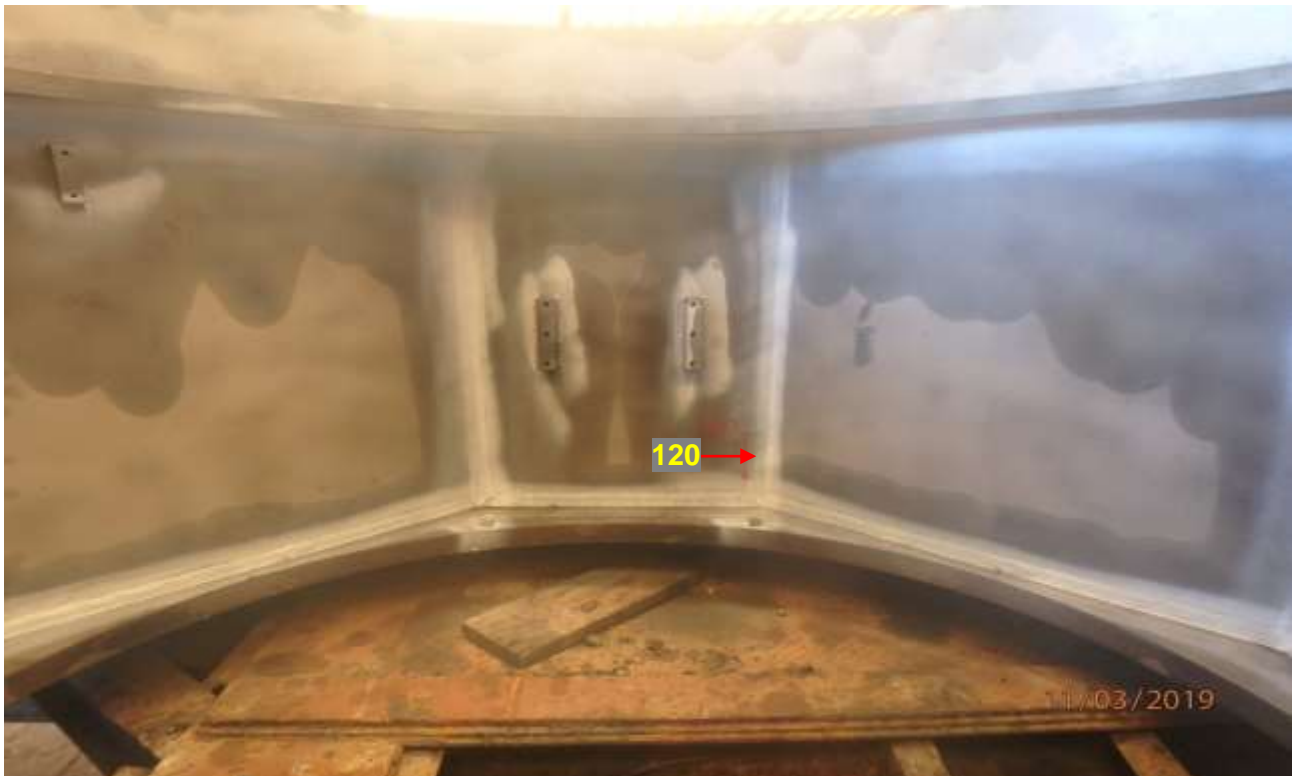
**Photograph 1.3.**

General view of areas examined and cracking detected about Carbody, Rear Internal JNJ19955

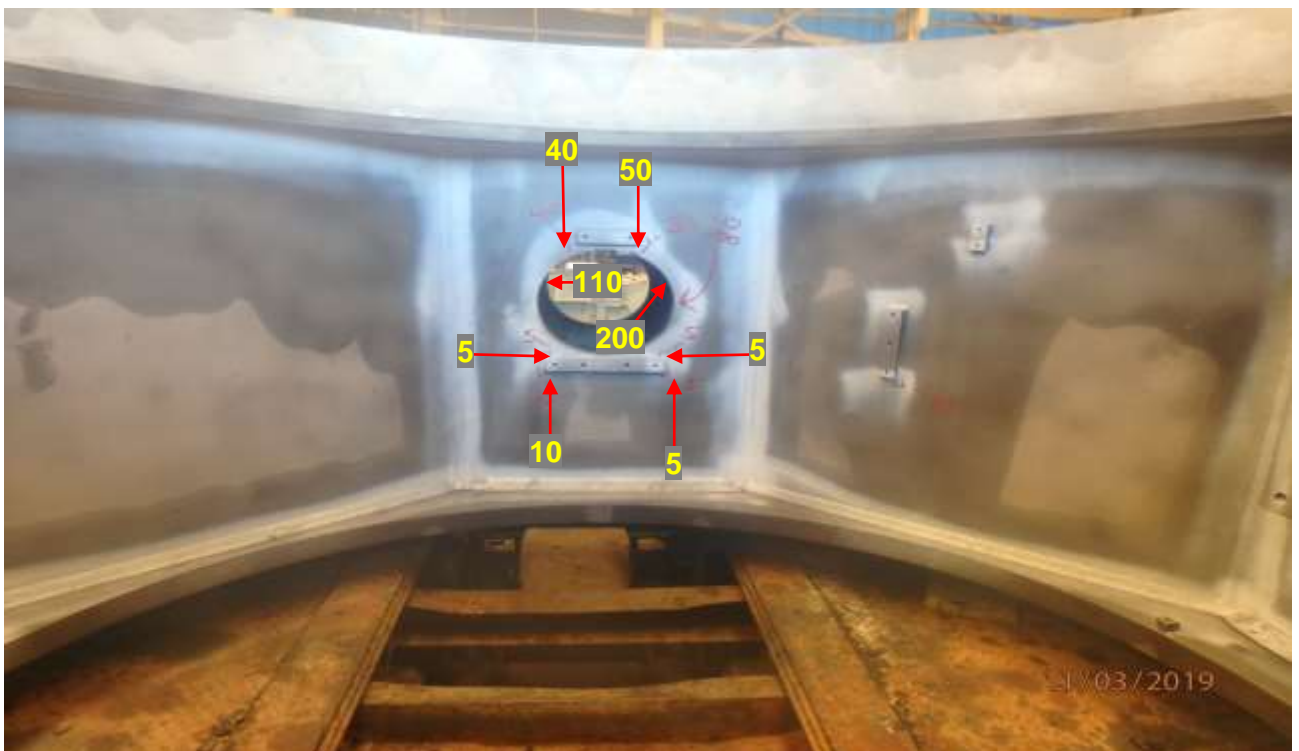
**Photograph 1.4.**

General view of areas examined and cracking detected about Carbody, LHS Internal JNJ19955

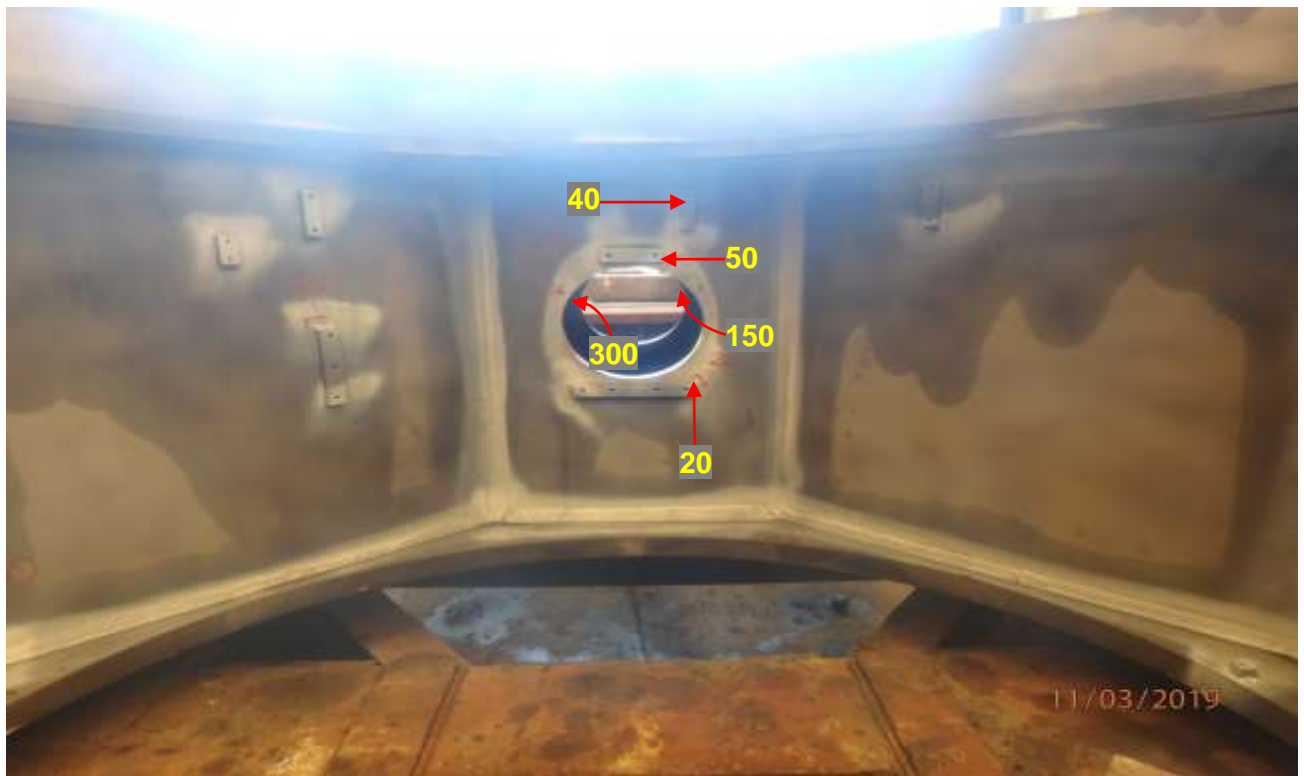
**Photograph 1.5.**

General view of areas examined and cracking detected about Carbody, RHS Internal JNJ19955

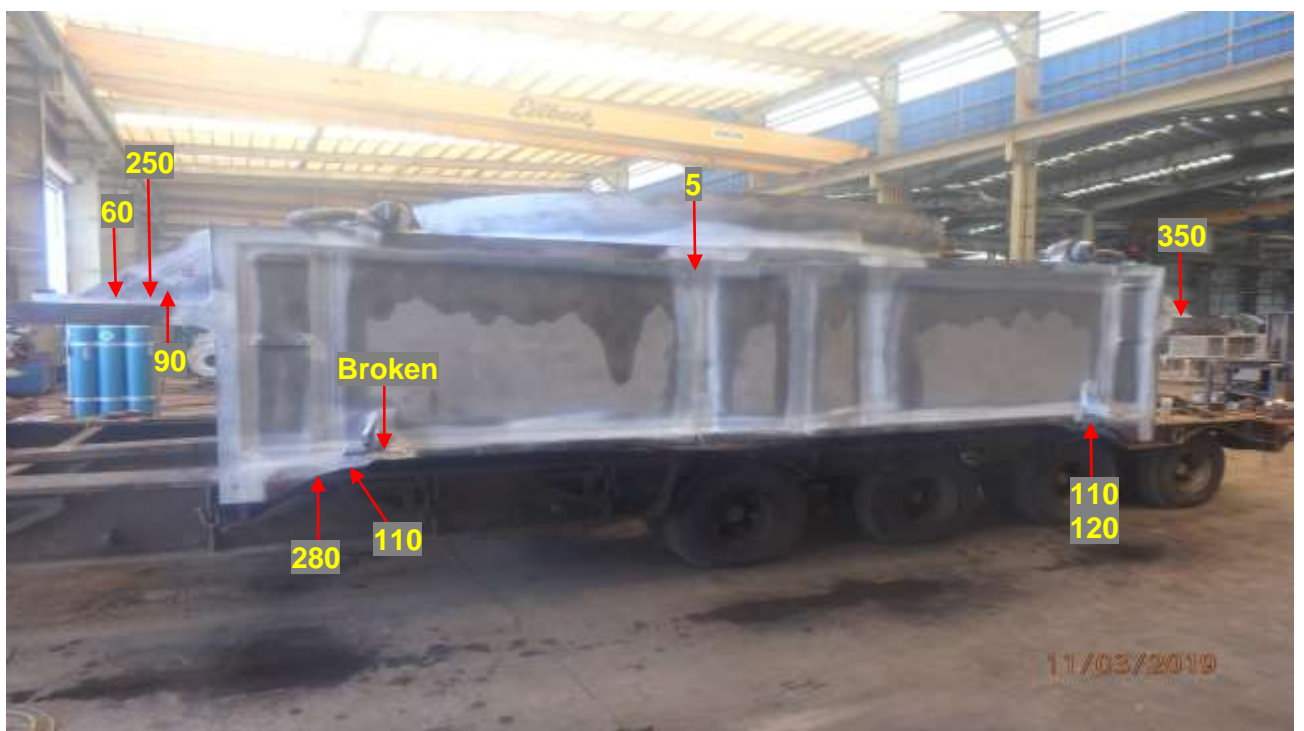
**Photograph 1.6.**

General view of areas examined and cracking detected about Carbody, Front External JNJ19955

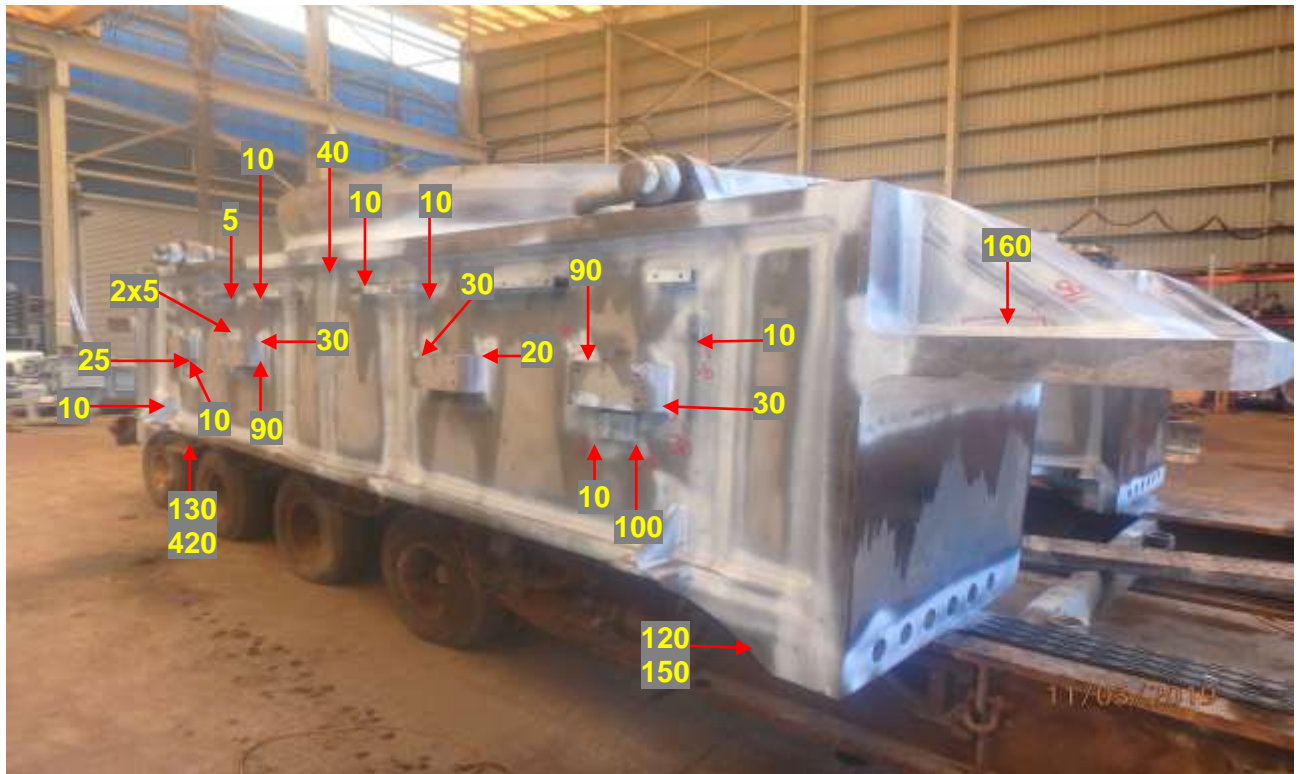
**Photograph 1.7.**

General view of areas examined and cracking detected about Carbody, Rear External JNJ19955

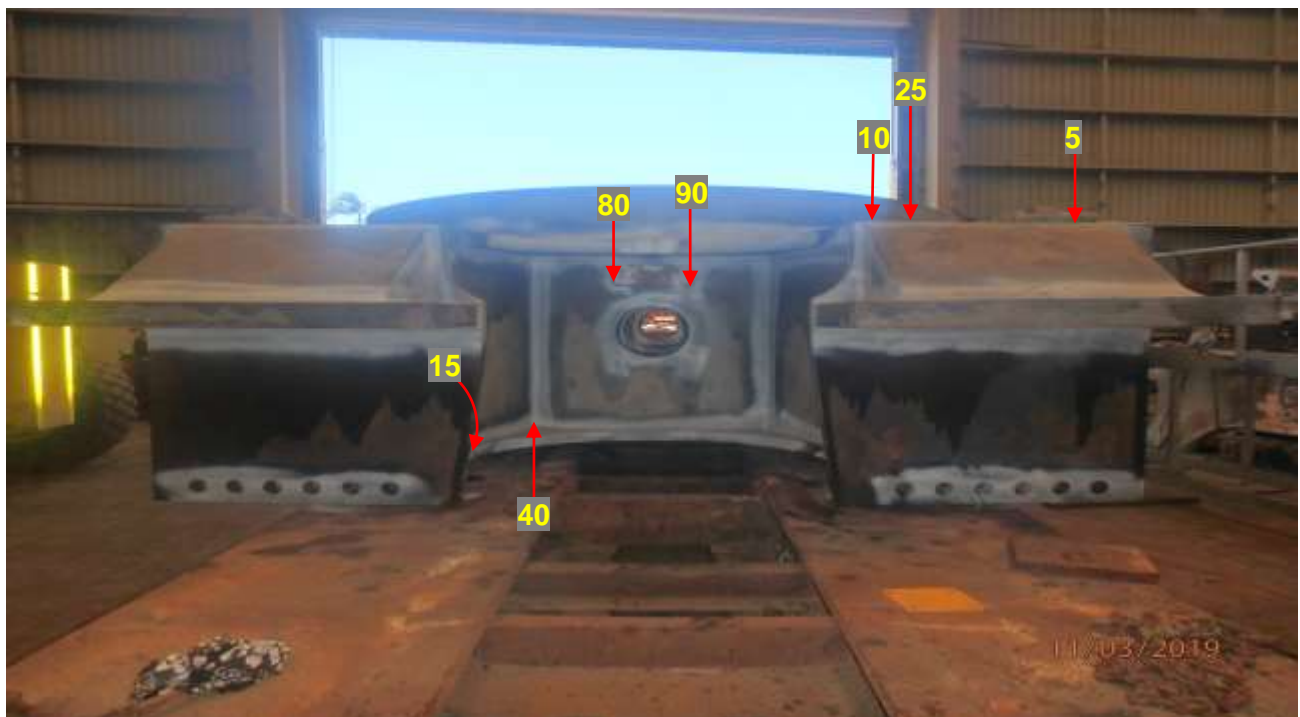
**Photograph 1.8.**

General view of areas examined and cracking detected about Carbody, LHS External JNJ19955

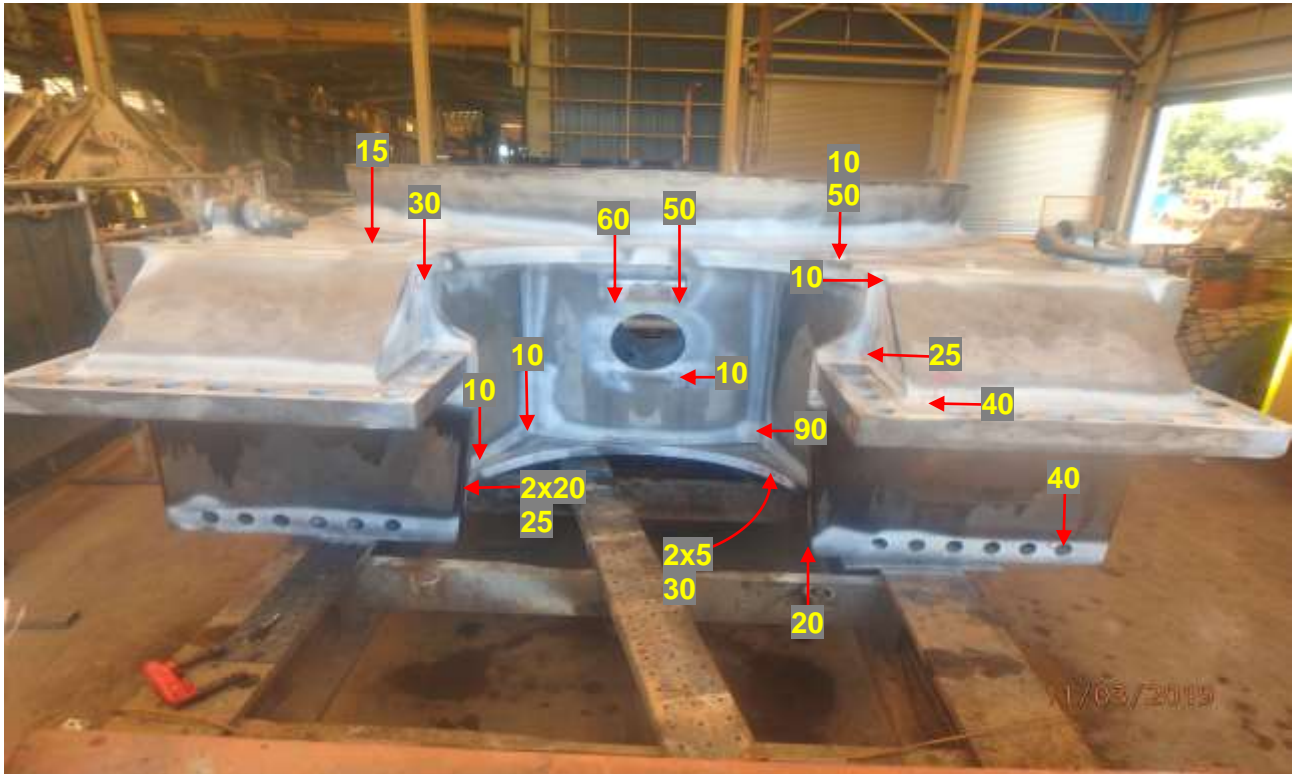
**Photograph 1.9.**

General view of areas examined and cracking detected about Carbody, RHS External JNJ19955
