INSPECTION REPORT NO. M20-015

COMPONENT IDENTIFICATION: **Caterpillar 6060 Excavator Superstructure**

SUBJECT: Inspection and non-destructive testing of
Caterpillar 6060 excavator superstructure at
Minespec Parts, Nebo.

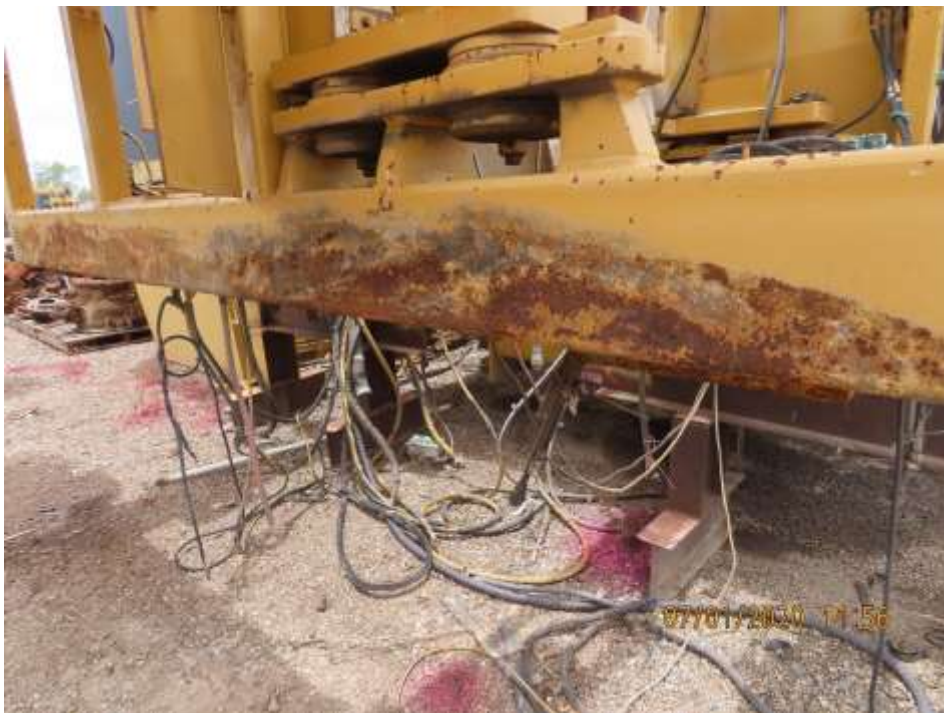
PHOTOGRAPH NO. 4 - Caterpillar 6060 excavator superstructure - corrosion detected on right hand side rail.

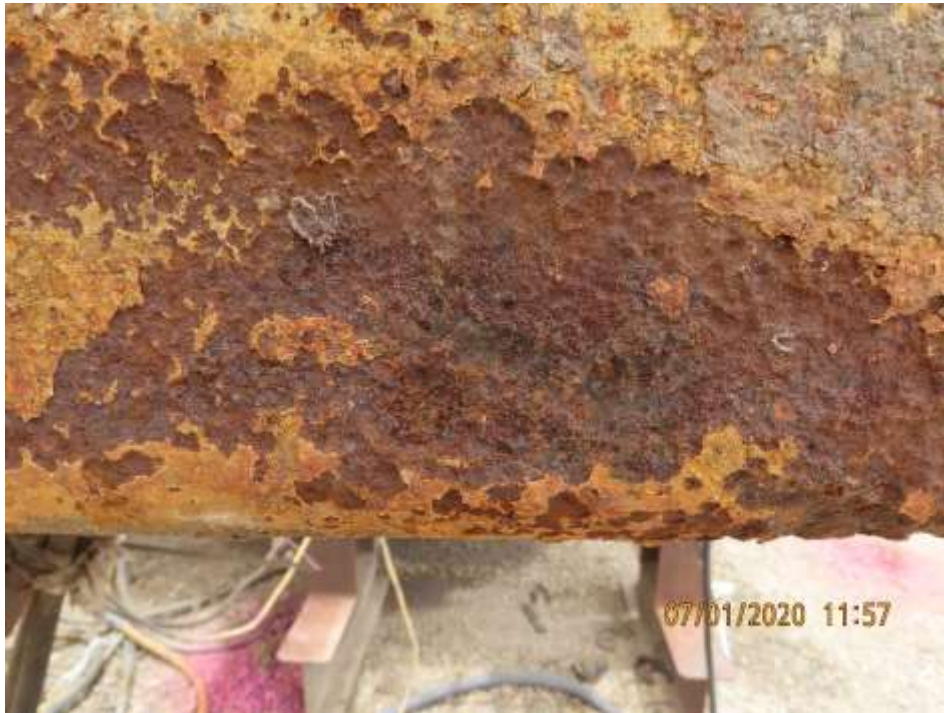
PHOTOGRAPH NO. 5 - Caterpillar 6060 excavator superstructure - corrosion detected on right hand side rail.

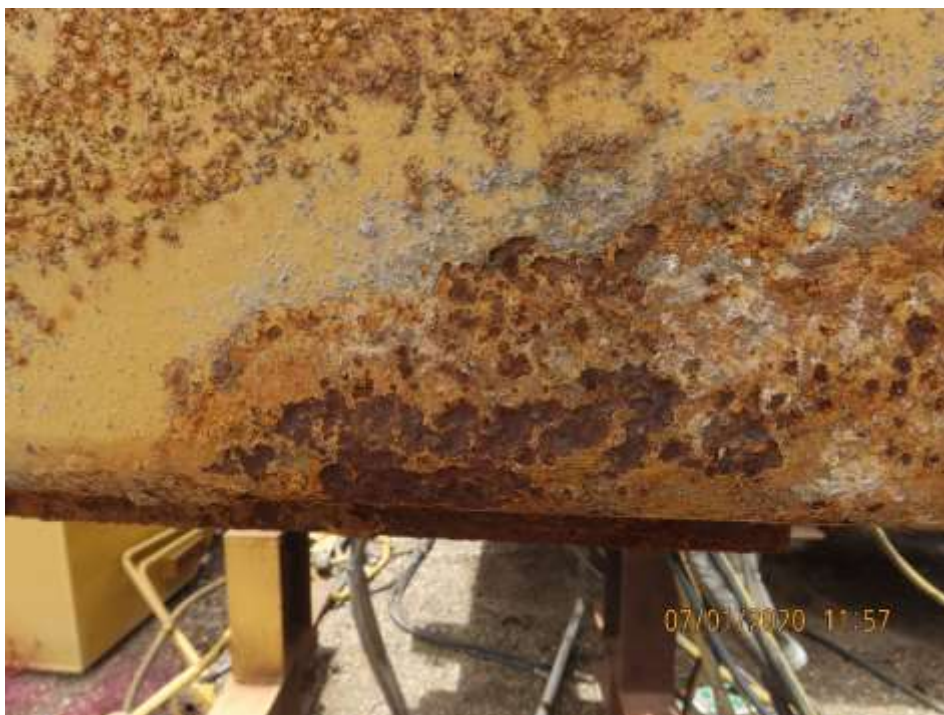
PHOTOGRAPH NO. 6 - Caterpillar 6060 excavator superstructure - corrosion detected on right hand side rail.

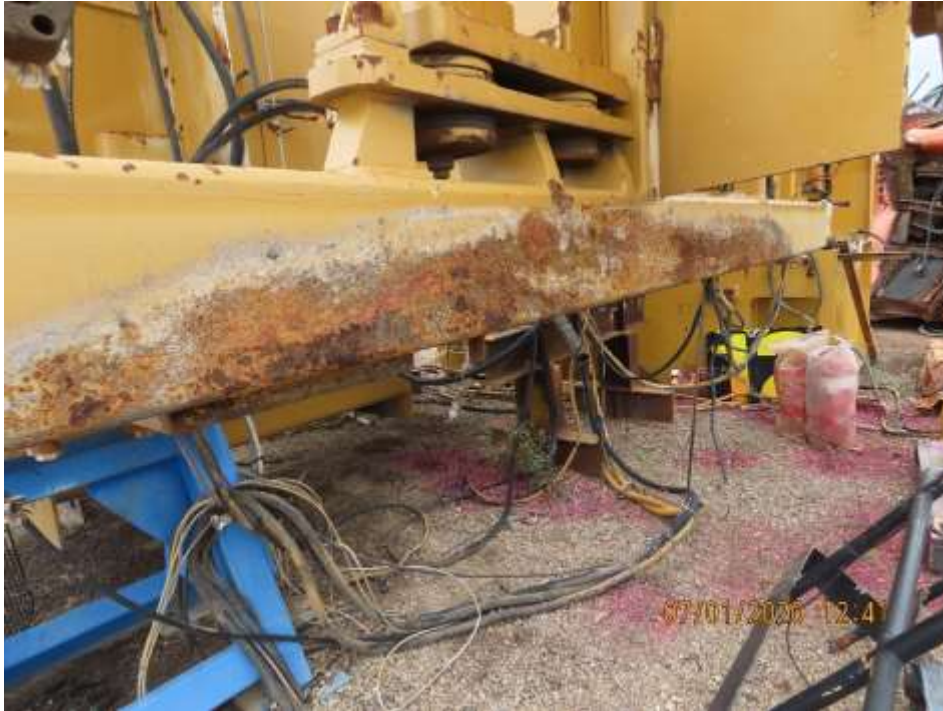
PHOTOGRAPH NO. 7 - Caterpillar 6060 excavator superstructure - corrosion detected on left hand side rail.

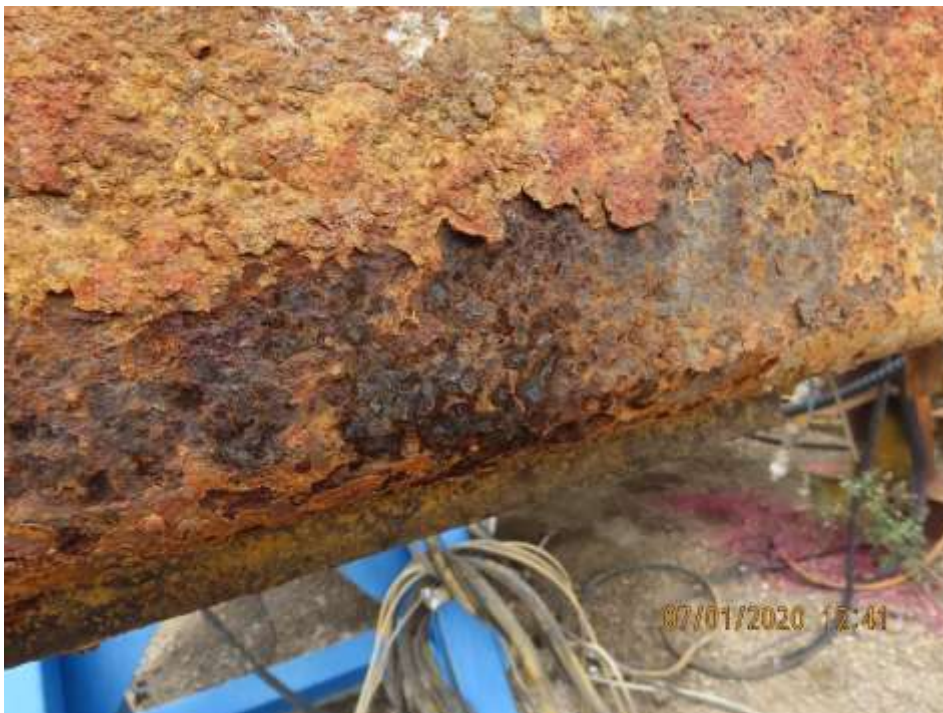
PHOTOGRAPH NO. 8 - Caterpillar 6060 excavator superstructure - corrosion detected on left hand side rail.

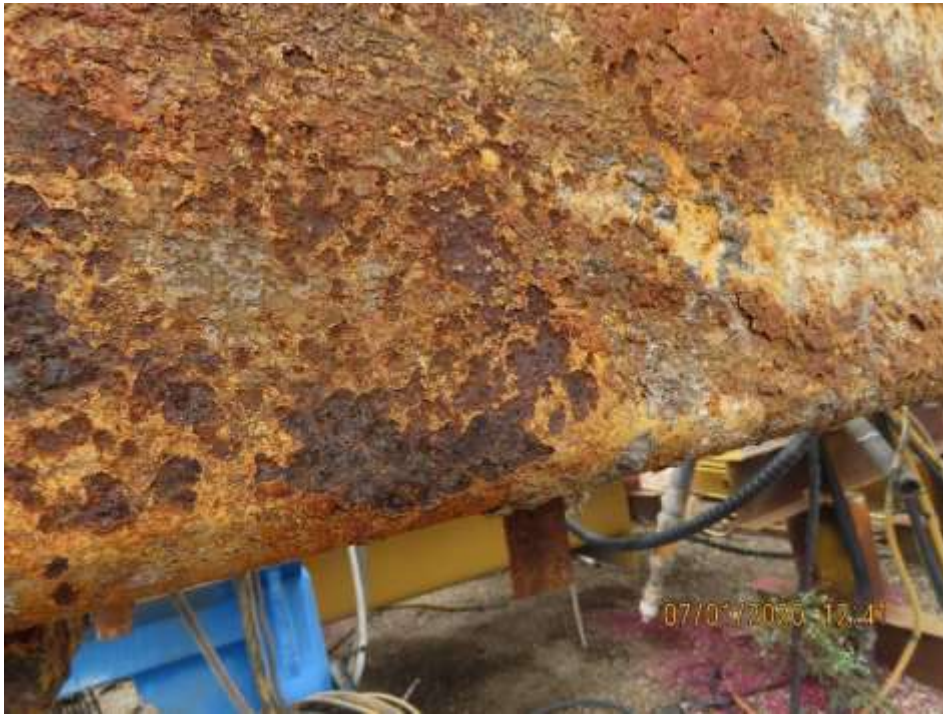
PHOTOGRAPH NO. 9 - Caterpillar 6060 excavator superstructure - corrosion detected on left hand side rail.

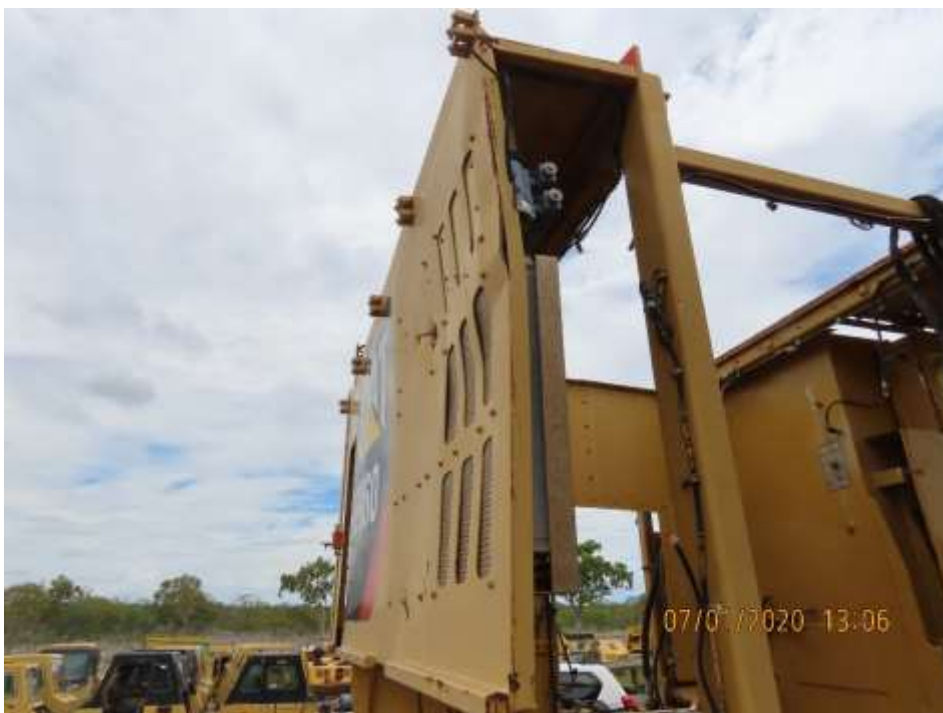
PHOTOGRAPH NO. 10 - Caterpillar 6060 excavator superstructure - mechanical damage detected on left hand side panel

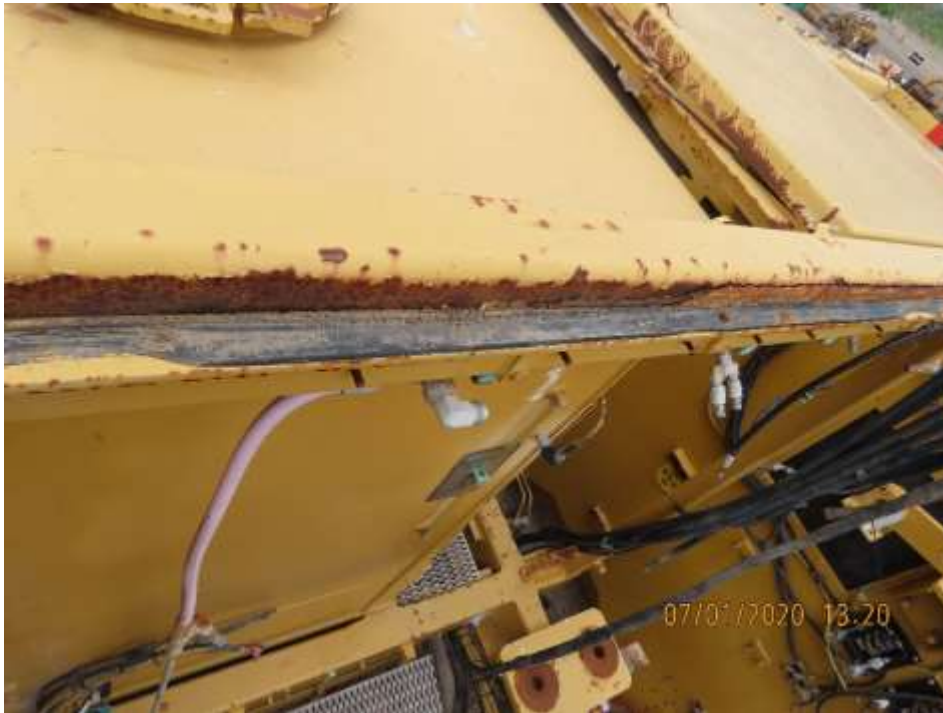
PHOTOGRAPH NO. 11 - Caterpillar 6060 excavator superstructure - corrosion detected on top cross beam.

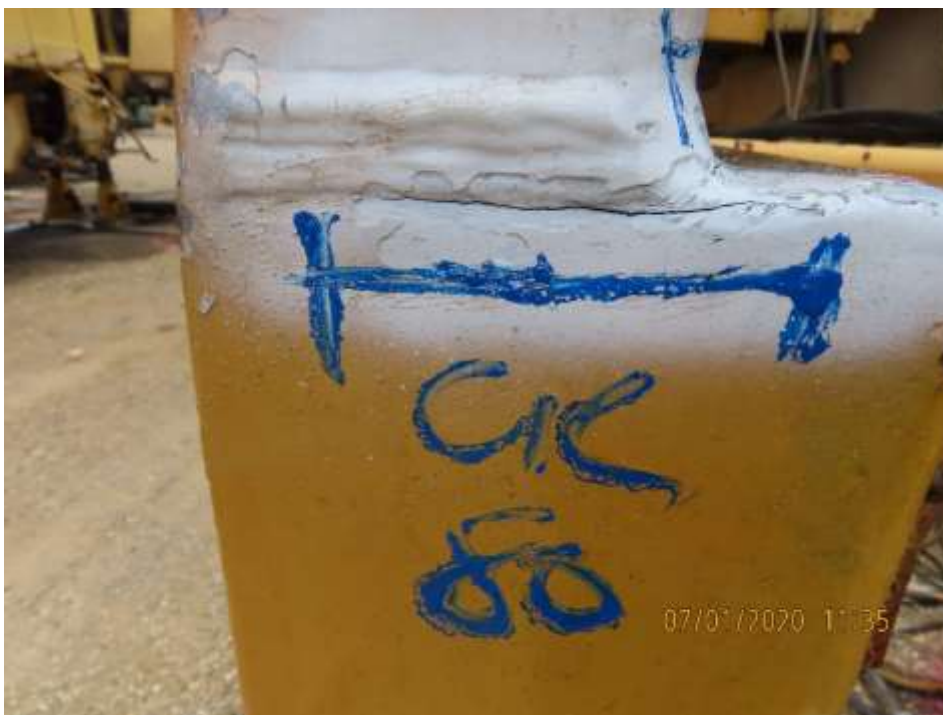
Defect No.	Photo No.	Defect	Location
1	12	Crack 80mm	Base of column right front
2	13	Crack 46mm	Base of column right front
3	14	Crack 50mm	Base of column right front
4	15	Crack 30mm	Base of column rear left inboard
5	16	Crack 40mm	Rear cross member left inboard
6	17	Crack 14mm	Rear cross member right inboard
7	18	Cracks 200mm, 186mm, 152mm, 101mm, 93mm & 72mm	Thin metal panel rear
8	19	Cracks 402mm, 170mm, 135mm, & 80mm	Thin metal panel front
9	20	Crack	Roof support left side
10	21	Crack	Roof support left side
11	22	Crack	Roof support right side
12	23	Crack	Roof support right side
13	24	Crack	Roof support right side

PHOTOGRAPH NO. 12 - Caterpillar 6060 excavator superstructure - 80mm crack detected.

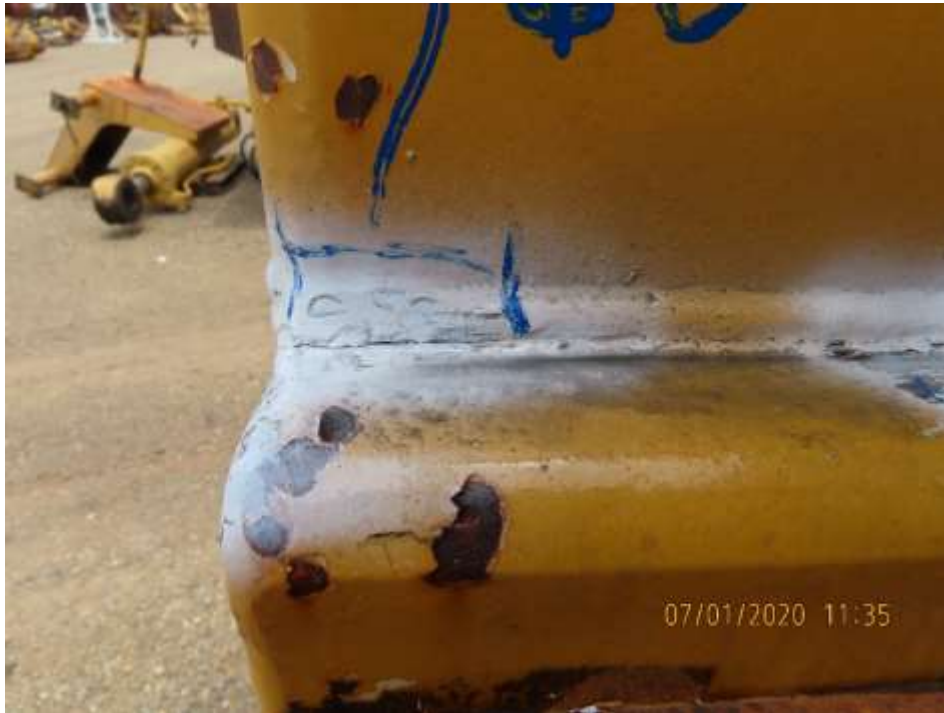
PHOTOGRAPH NO. 13 - Caterpillar 6060 excavator superstructure - 46mm crack detected.

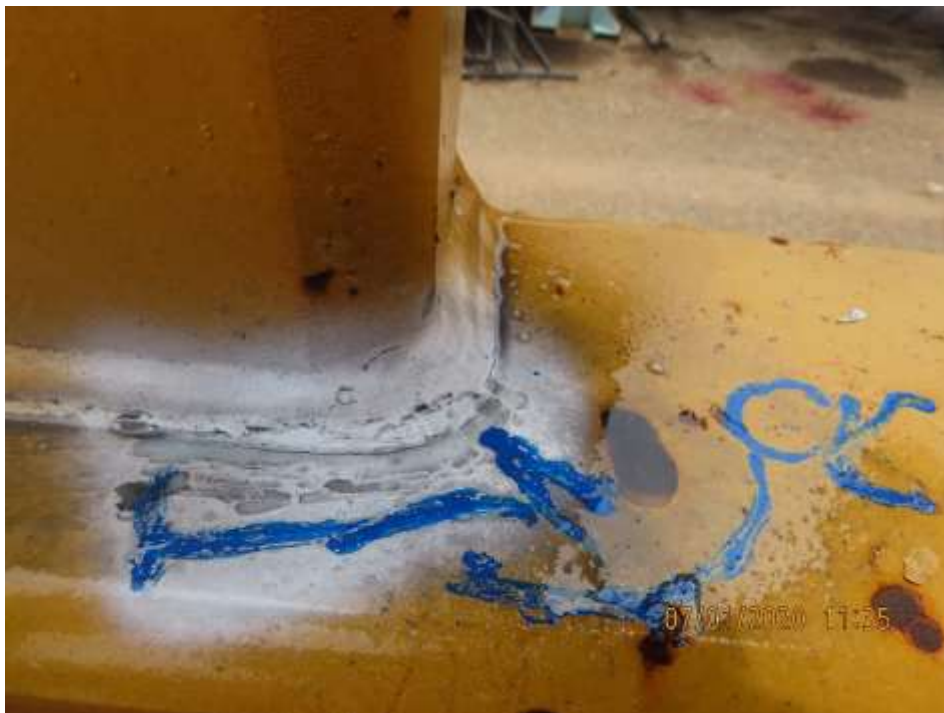
PHOTOGRAPH NO. 14 - Caterpillar 6060 excavator superstructure - 50mm crack detected.

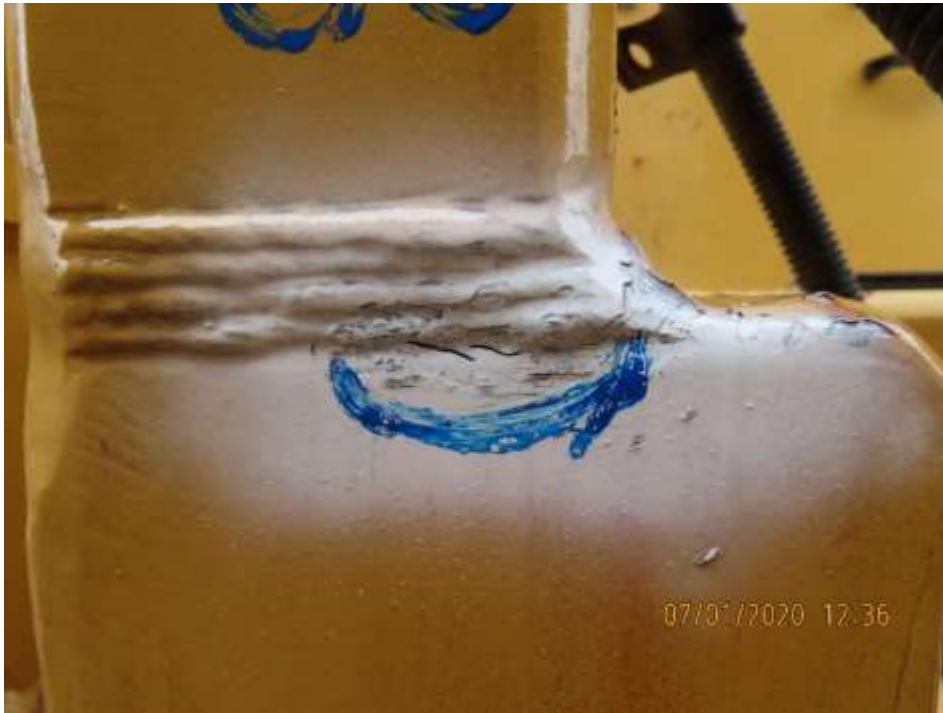
PHOTOGRAPH NO. 15 - Caterpillar 6060 excavator superstructure - 30mm crack detected.

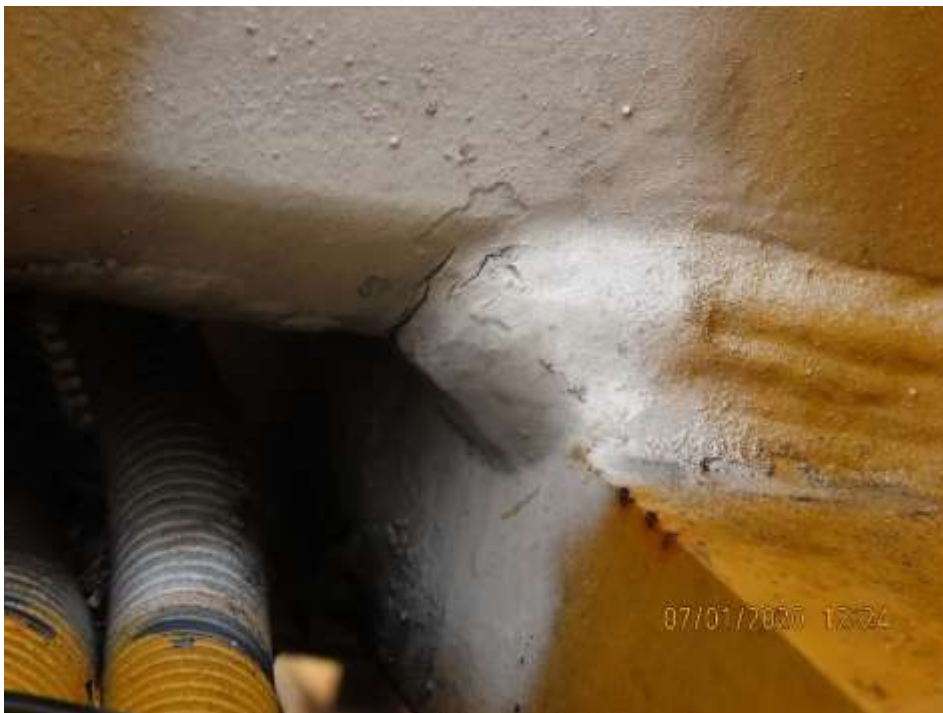
PHOTOGRAPH NO. 16 - Caterpillar 6060 excavator superstructure - 40mm crack detected.

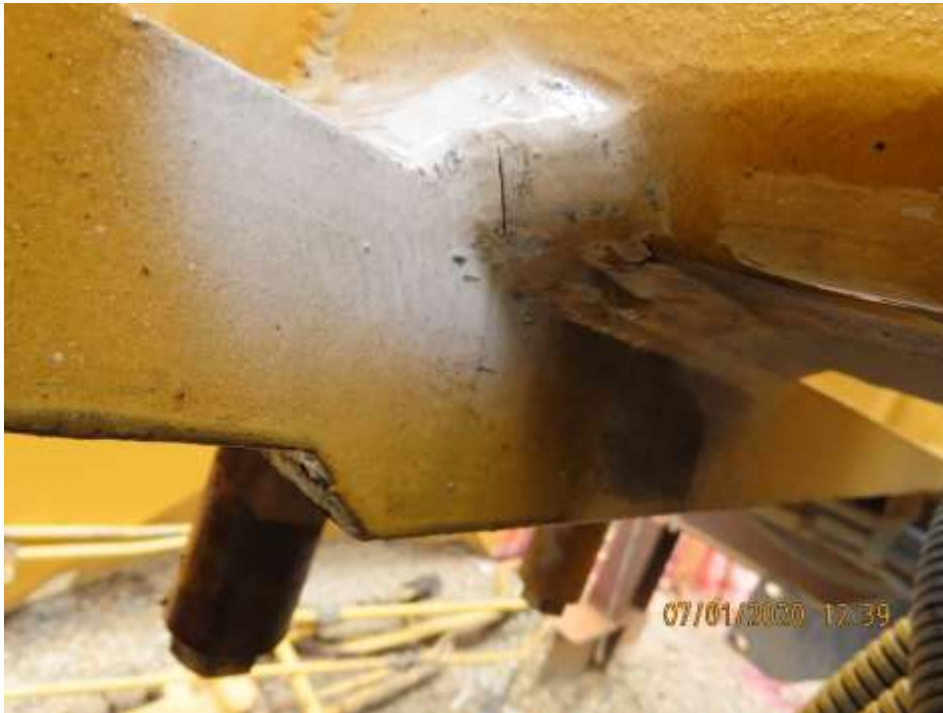
PHOTOGRAPH NO. 17 - Caterpillar 6060 excavator superstructure - 14mm crack detected.

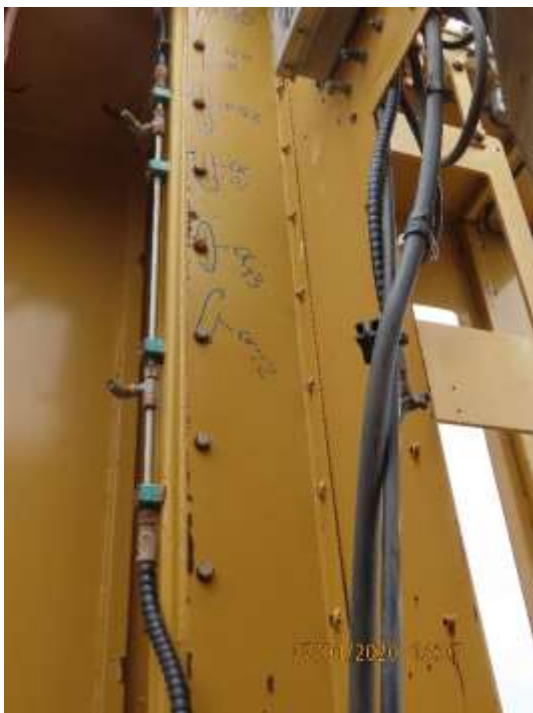
PHOTOGRAPH NO. 18 - Caterpillar 6060 excavator superstructure
200mm, 186mm, 152mm, 101mm, 93mm & 72mm
cracks detected.

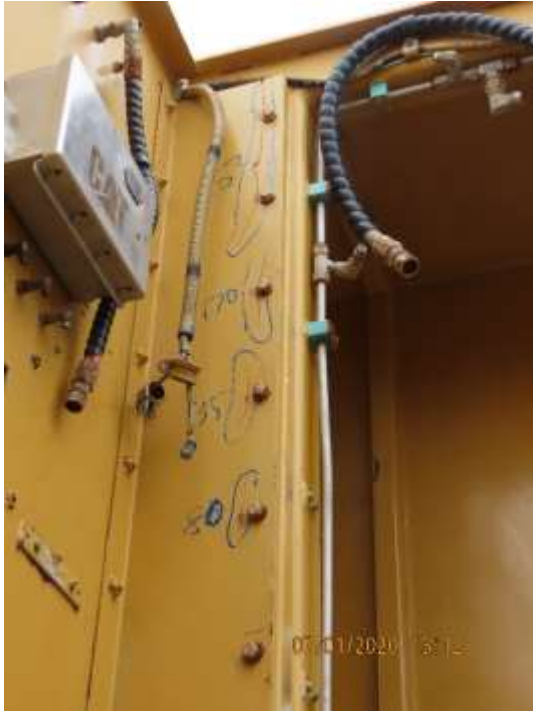
PHOTOGRAPH NO. 19 - Caterpillar 6060 excavator superstructure
402mm, 170mm, 135mm & 80mm cracks detected.

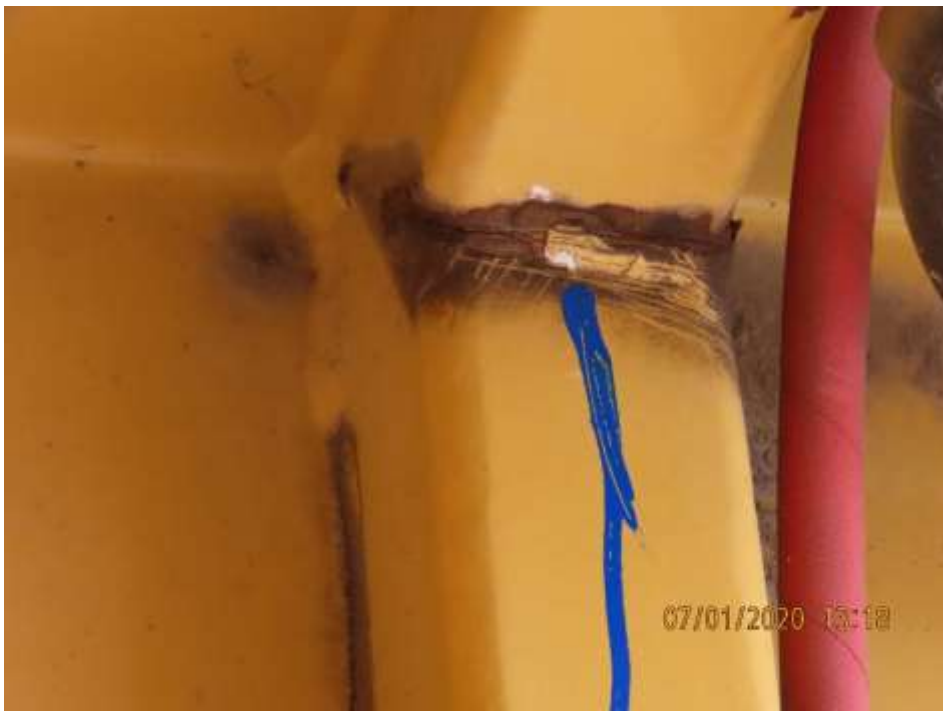
PHOTOGRAPH NO. 20 - Caterpillar 6060 excavator superstructure - crack
detected on roof support.

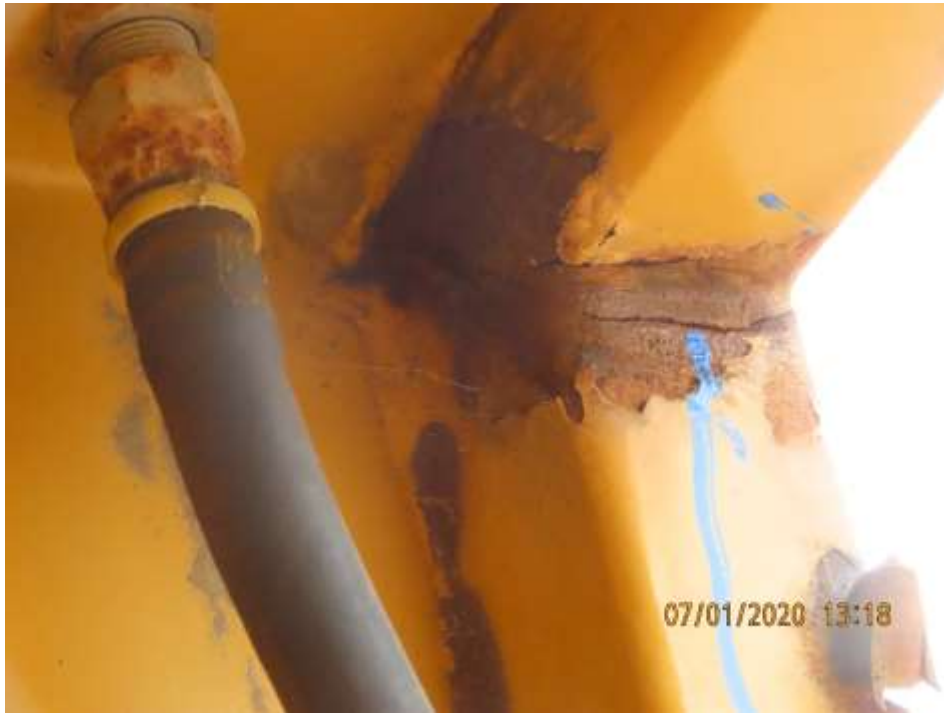
PHOTOGRAPH NO. 21 - Caterpillar 6060 excavator superstructure - crack detected on roof support

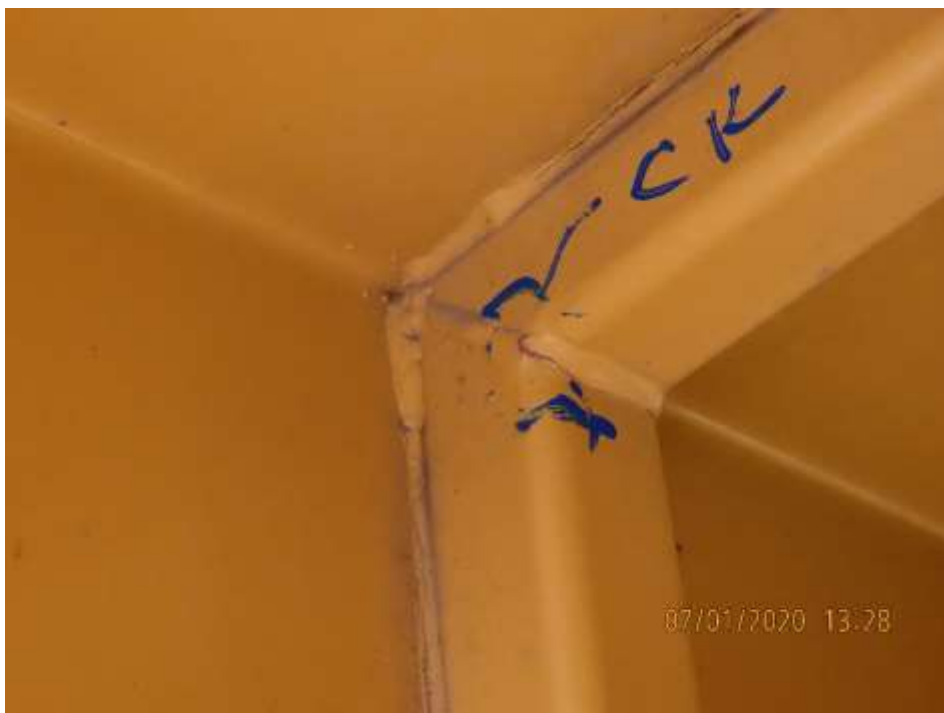
PHOTOGRAPH NO. 22 - Caterpillar 6060 excavator superstructure - crack detected on roof support.

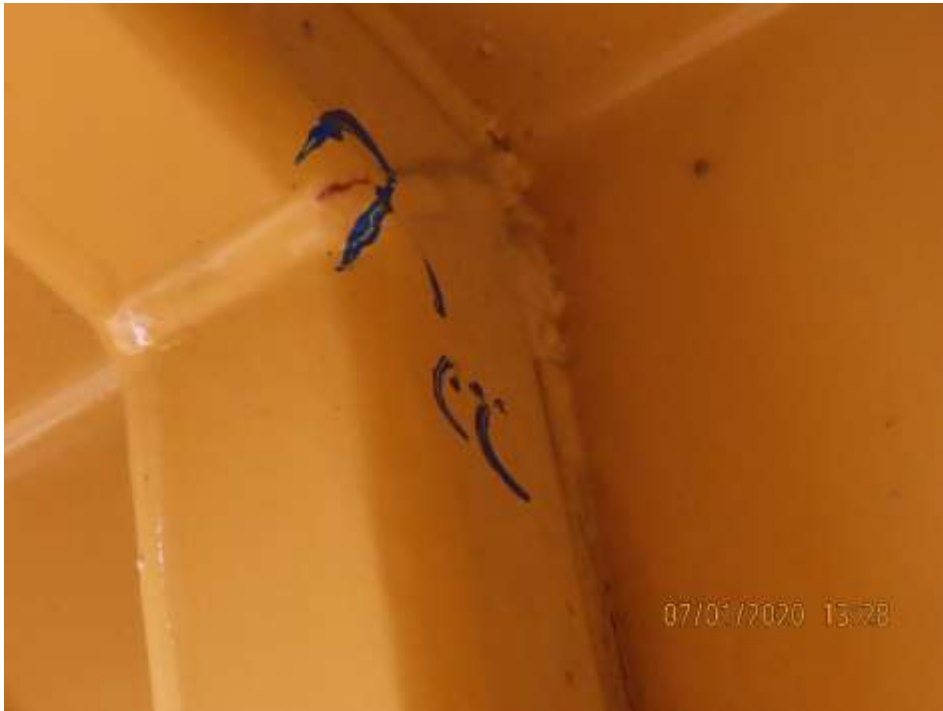
PHOTOGRAPH NO. 23 - Caterpillar 6060 excavator superstructure - crack detected on roof support.

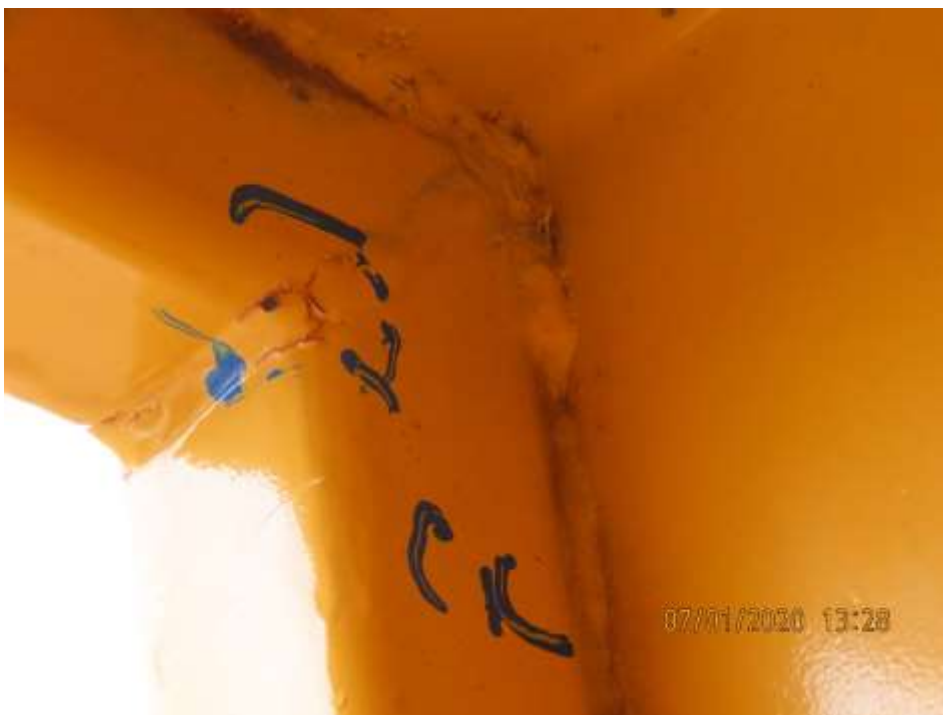
PHOTOGRAPH NO. 24 - Caterpillar 6060 excavator superstructure - crack detected on roof support.
