INSPECTION REPORT NO. M20-717

COMPONENT IDENTIFICATION: **Komatsu WA900 Loader Front Axle Housing Spindles**

SUBJECT: Inspection and non-destructive testing of Komatsu WA900 loader front axle housing spindles at Minespec Parts, Nebo.

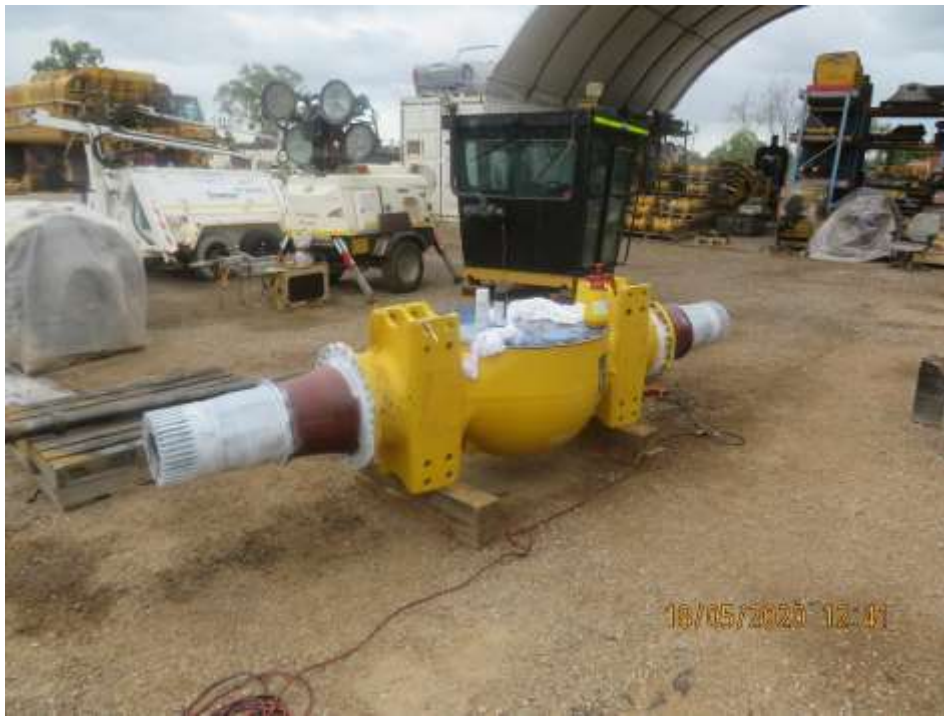
PHOTOGRAPH NO. 1 - Locations tested

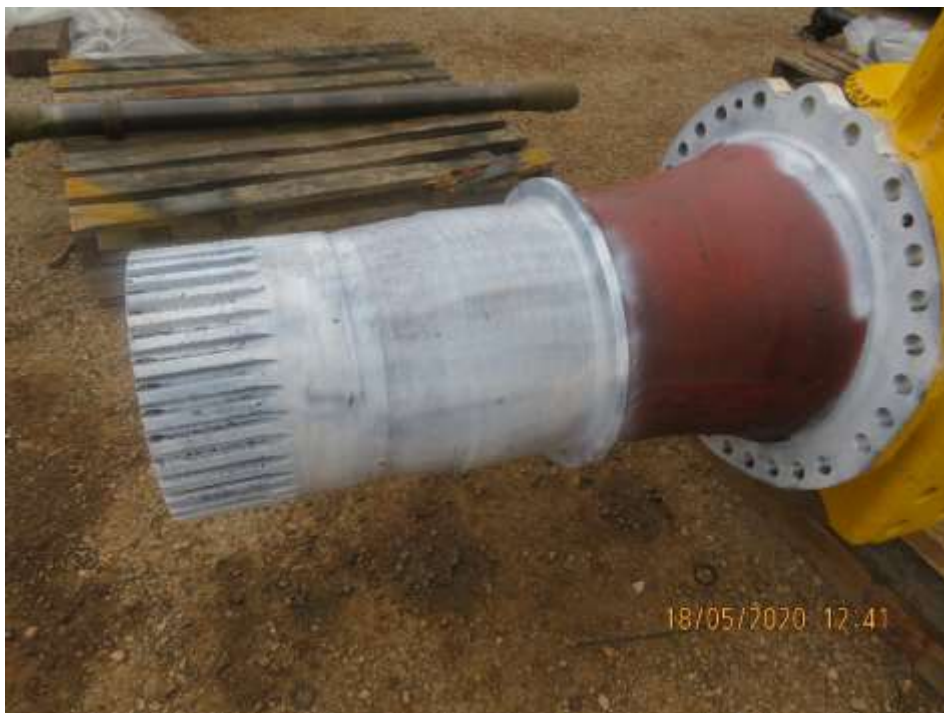
PHOTOGRAPH NO. 2 - Locations tested

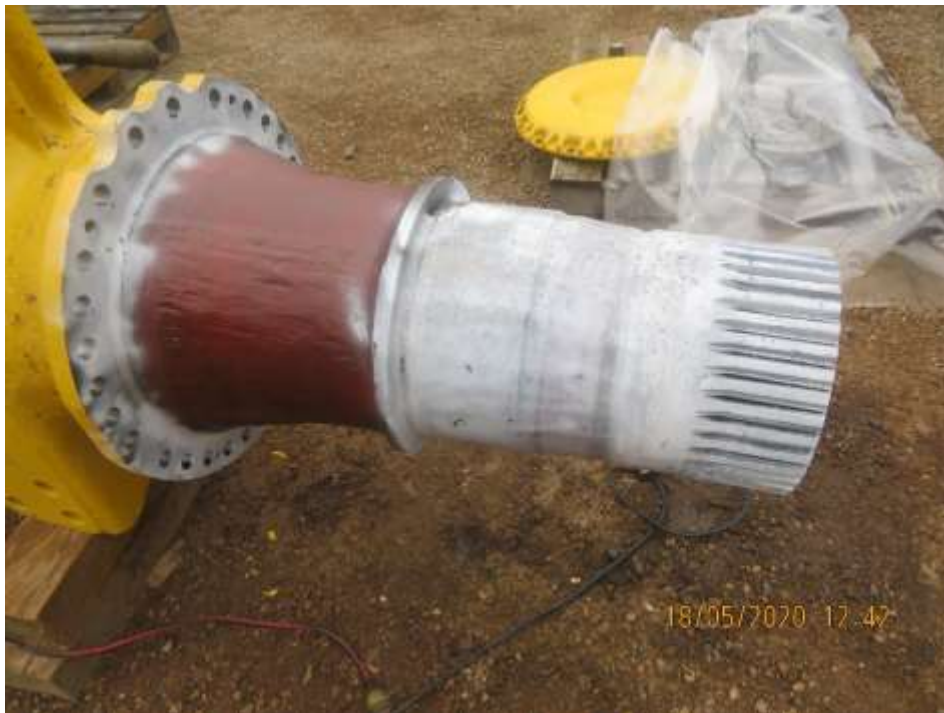
PHOTOGRAPH NO. 3 - Locations tested

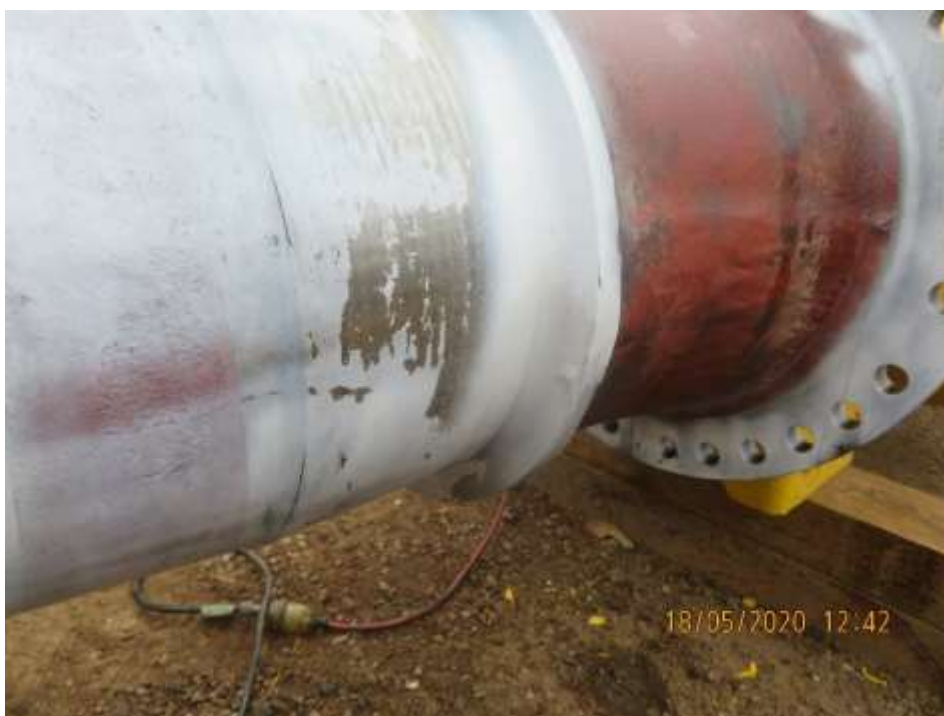
(MT) - Cracks detected, refer to Photograph Nos. 4 - 9.

PHOTOGRAPH NO. 4 - Cracks detected

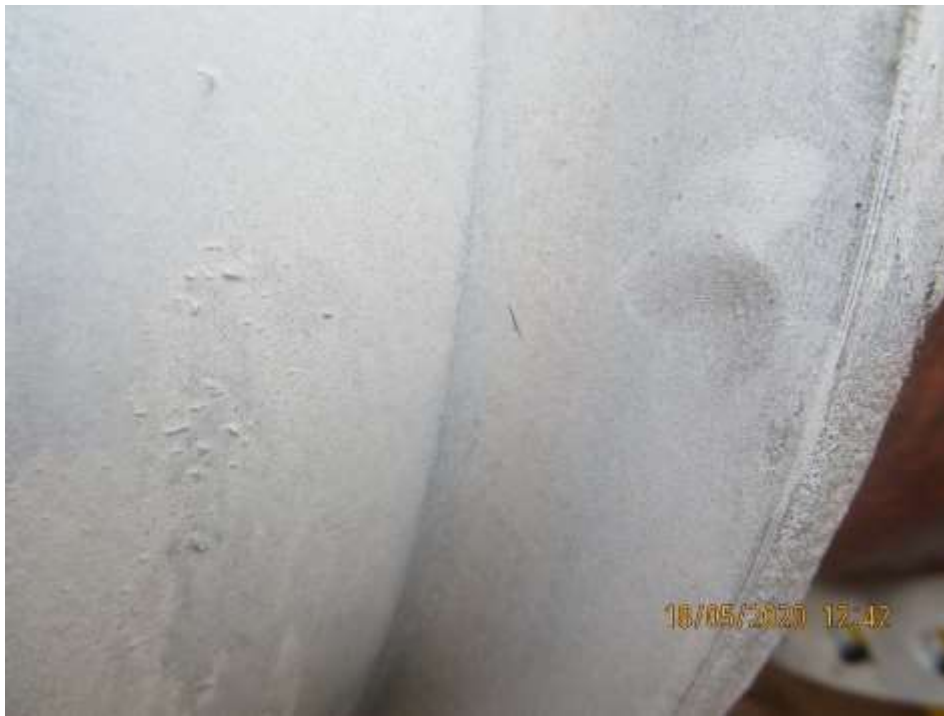
PHOTOGRAPH NO. 5 - Crack detected (location)

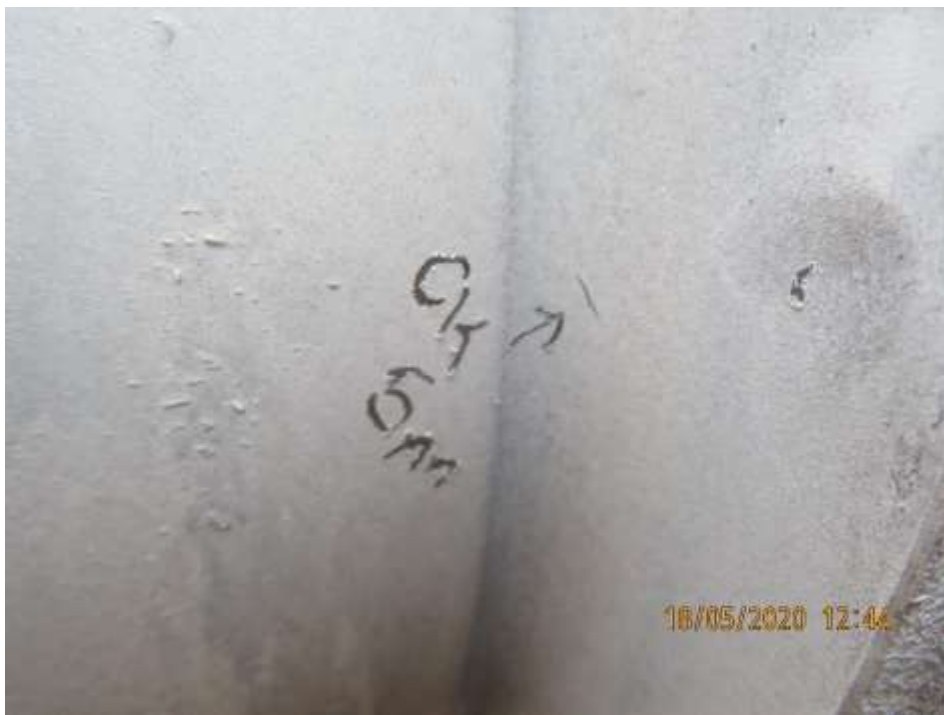
PHOTOGRAPH NO. 6 - 5mm crack detected

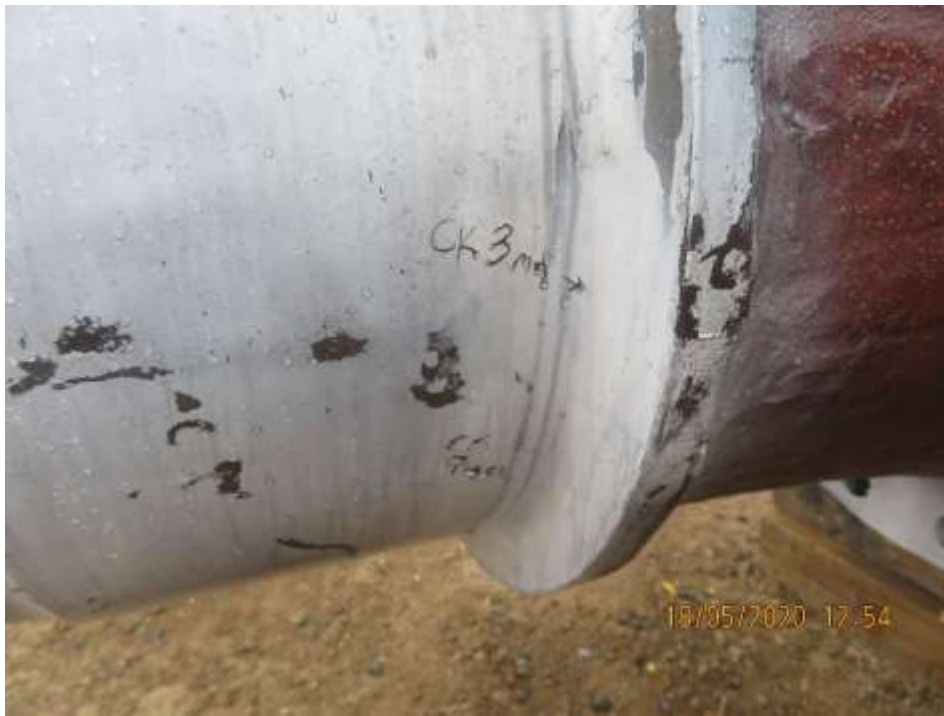
PHOTOGRAPH NO. 7 - Cracks detected (location)

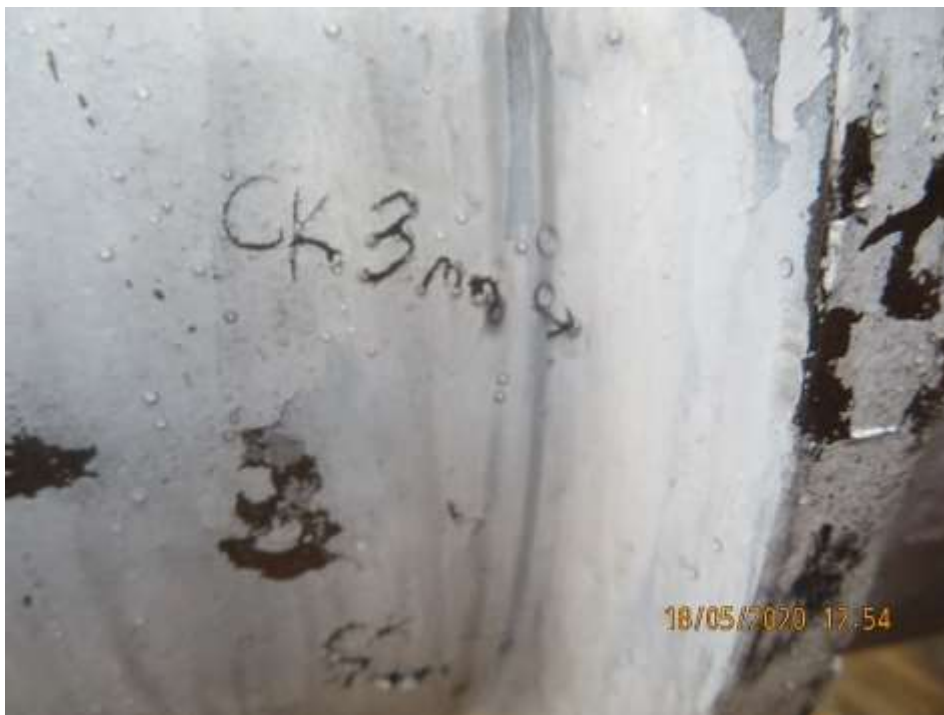
PHOTOGRAPH NO. 8 - 3mm crack detected

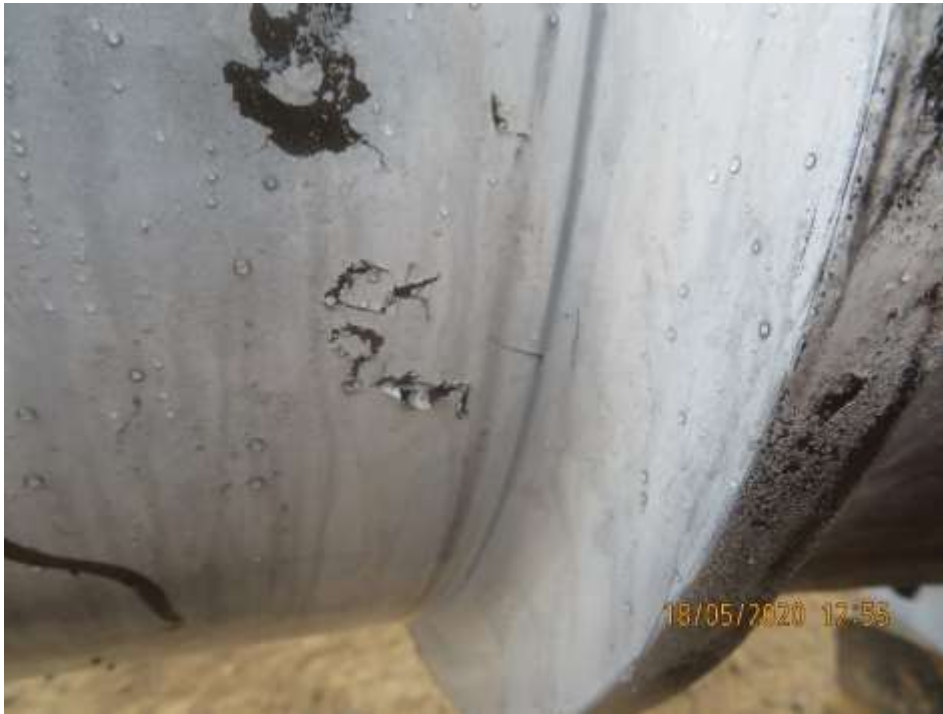
PHOTOGRAPH NO. 9 - 9mm crack detected
