TYRE INSPECTION REPORT

Company: THIESS/EASTERN TRACTORS

Site: MT THORLEY

Veh. Make & type: CAT789B

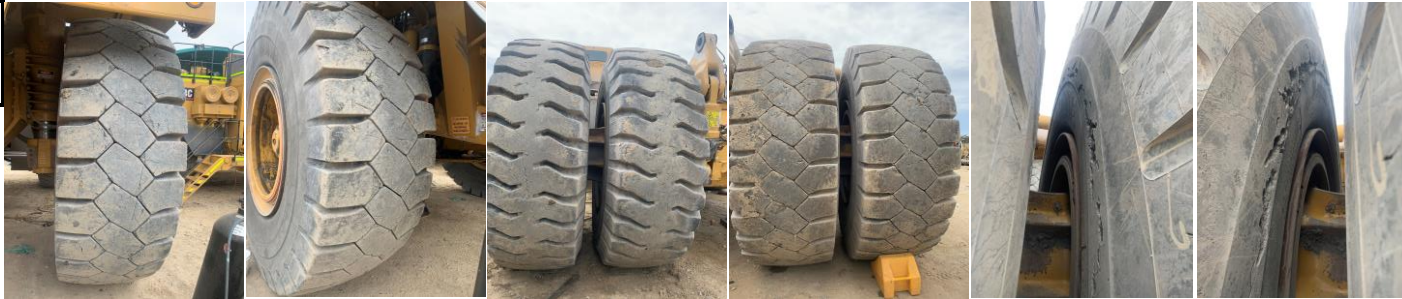
POS 1/2 TYRES OK
POS 5/6 THE WORST WITH SIDEWALL DAMAGE ON BOTH INSIDES OF TYRES
WITH POS 6 SIDEWALL CUTS TO OUTSIDE

POSITION 5/6 SIDEWALL DAMAGE
